Restoring the KLH Model Eight Table Radio

the best radio ever built

This guide is based on my experience restoring dozens of these and is intended for the advanced hobbyist. You don’t have to be a technician (I’m not) or have the ability to read a schematic. If you were comfortable building a *dynakit* you should be able to follow these instructions.

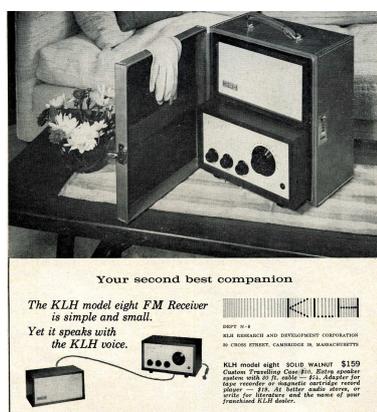
fig 1—carrying case

- A carrying case (*fig 1*). These are extremely rare.
- A phono adaptor/preamp. This allowed a mono turntable or tape deck to be connected to the Eight. There were two versions of the adaptor. One had a power cord and was to be used with Rev A receivers, the other was for Rev B receivers and had no power cord (*fig 2*).

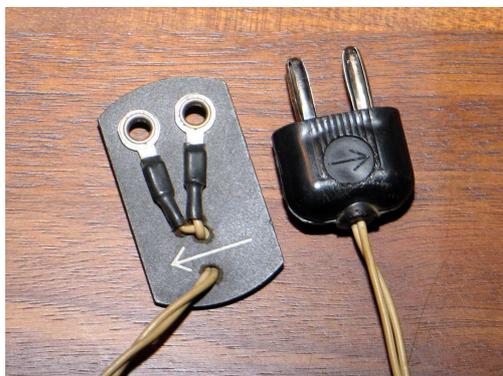
fig 3—extension speaker plug (left)

- Extension speaker. This was a second speaker, identical to the KLH Eight speaker but it had a volume control and a unique plug (*fig 3*) that was sandwiched between the Model Eight speaker plug and the receiver. These are rare, and even when they do turn up they are often missing the special plug adaptor and have two banana plugs so the speaker can be used instead of the original.

- How does the speaker cloth look? Water stains are common. Is the KLH logo badge on the cloth?
- Is the 30 foot white twisted pair speaker wire intact? The proprietary double banana plug (on the right in *fig 3*) is often missing due to a design flaw (weak point where the wire meets the molded plug), and typically will have been replaced with two standard banana plugs.

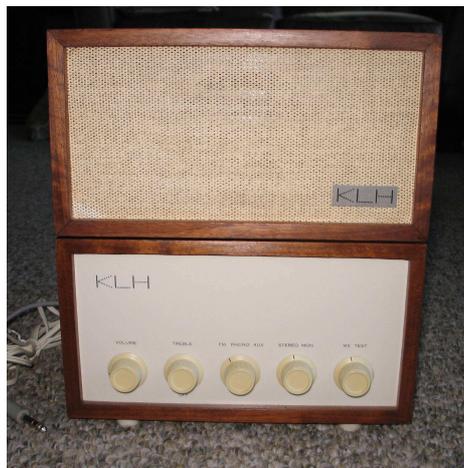
fig 4—KLH Model Thirteen

- The Model Thirteen. The Thirteen consisted of a second box and another speaker, to convert the Eight to stereo (*fig 4*). The FCC had not yet approved stereo FM broadcasts when the Eight was introduced in 1960 but approval was imminent and KLH was prepared when it came just one year later. The Model Thirteen represented the switch from vacuum tubes to solid state. It may have been the first compact stereo system, with inputs for Phono and Aux.

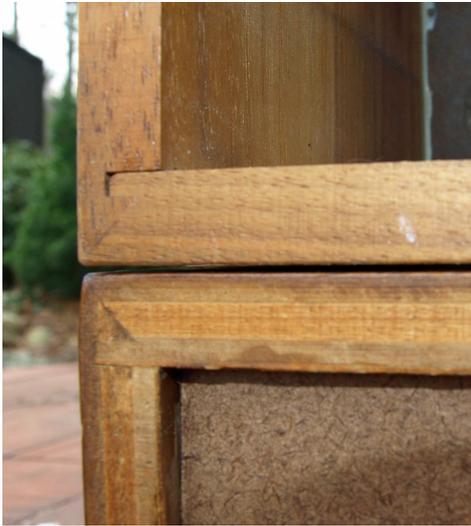
fig 5 --Veneer (bottom) and solid (top) cabinets

- What is the condition of the cabinets? Are there any scratches, gouges, corner dings, water stains, etc? Early cabinets were solid walnut while later ones were high quality walnut veneered plywood. A look at the back edges on both the receiver and speaker will reveal what you have (*fig 5*).

This is a gentle stripper, but use gloves and work in a well ventilated area. The solid cabinets can be sanded aggressively with an orbital sander if necessary. I would NOT sand veneer unless absolutely necessary—and then only by hand. For veneer cabinets I recommend *Howard's Restor-a-Finish*, available at hardware stores, online and Home Depot.

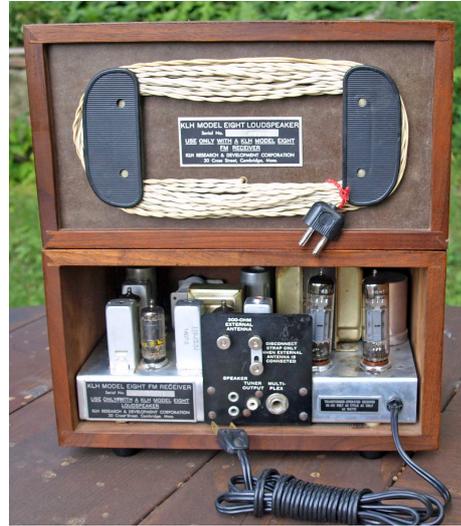
fig 6 – Radio back

- Are the plastic cleats on the back of the speaker intact? These are often broken.
- Other things to look for are the metal labels; two on the back of the receiver and one on the back of the speaker. Serial numbers rarely match (I have an original factory carton, with serial numbers of the receiver and speaker on the outside. They don't match). Check the AC power cord for cracks and stiffness. There should be 3 knurled nuts and a small strap on the back of the receiver for the antenna connections (*fig 6*).

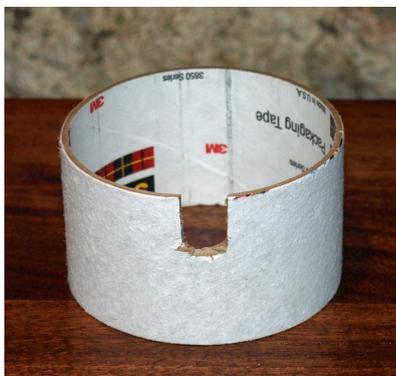
fig 7—Tim’s knob-removal “tool”

The receiver chassis can be removed by *gently* removing the knobs and unscrewing the four Phillips-head screws holding the feet to the bottom of the cabinet. To remove the knobs use your fingers and fingernails only. Rock and pull straight out. Do not use a screwdriver or any other tool to pry the knobs—you run the risk of breaking the brittle plastic or damaging the painted faceplate. Removing the feet first will allow the chassis to shift and may give you more room to grasp the knobs. If needed, make a knob-puller from the cardboard center of a roll of packing tape (*fig 7*). Cut a notch and slip it under the knob, so the shaft slips into the notch (thanks to Tim Schwartz of Bristol Electronics for this and many other tips).

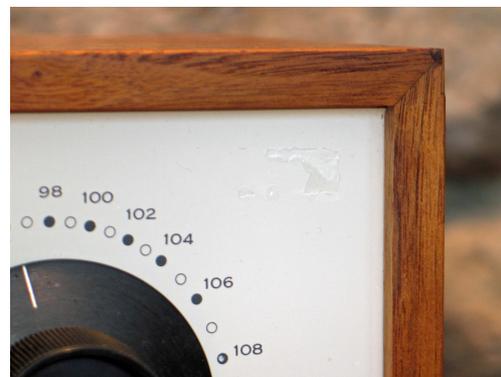
fig 8 – repaired paint chip

Once the knobs and feet have been removed, slide out the chassis and set it aside. The painted faceplate can be cleaned with soap and water, *Fantastik*, *409* or similar cleaner. Do NOT use any kind of abrasive! If the faceplate is scratched or the lettering is rubbed off there is little you can do. I have touched up small scratches and chips by spraying almond spray paint into a cup, then brushing it on with a very fine paintbrush but the repair will be visible (*fig 8*).

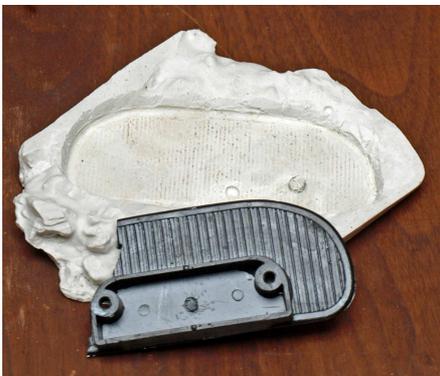
fig 9 – broken cleat & plaster mold

If a cleat is broken, you can remove it by drilling out the metal rivets. This is best accomplished from inside the speaker cabinet. Assuming the grille cloth has been removed, unscrew the #4 flat head Phillips screws holding the speaker baffle in place, and pull the baffle off. It is caulked with putty that is probably dried out and may require some gentle prying (be careful of the walnut frame), but it will come loose. Inside is some pink fiberglass insulation. Remove it (gloves and a mask are a good idea) and save it in a plastic bag. Now drill out the rivets from the inside. Later the cleats can be reattached with #4 machine screws, lock washers (or *Loctite*) and nuts.

To restore a cleat, I made a cast of an intact cleat using Plaster of Paris. A better choice would be a product for making molds, sold in art stores. After you have your mold, set the broken cleat in it, then pour in a mixture of *Plas-T-Pair*. This product may also be used for patching broken knobs.

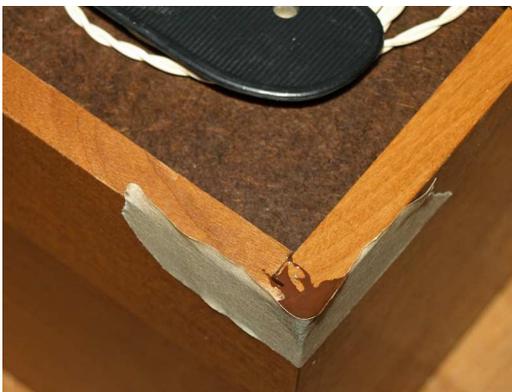
fig 11—corner bash, tape dam and epoxy filler

One useful trick I learned from John O'Hanlon is worth mentioning: For big gouges, corner bashes or open seams a filler can be made from 2-part clear epoxy and a pigment called *Mixol*.

Mixol is sold in art supply and woodworking stores. It comes in a small (20 ml) bottle, costs about \$5 and you need less than a drop added to your epoxy. "Tobacco" #22 is a good match for the dark walnut wood. On corners, build a dam out of masking tape and pour the epoxy mixture in (*fig 11*). Open seams can be re-glued by forcing the tinted glue into the joint with a razor blade or X-acto knife, then clamping (*fig 12*). After 24 hours it can be filed and sanded down. It is MUCH more durable than "plastic wood".

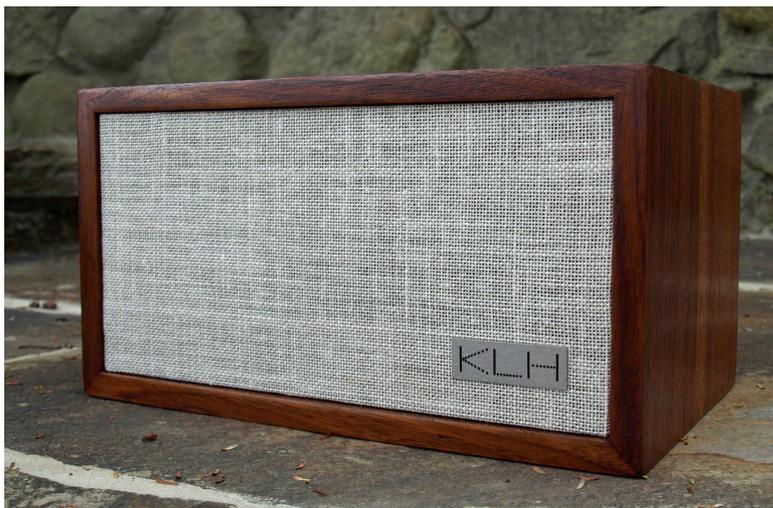
fig 13—Irish Linen grille cloth

then dry with a hair dryer. The fabric will shrink to be as tight as a drum (*fig 13*). You can spray it with *ScotchGard* if you want, then glue the KLH logo on with *Aleene's*. If the logo was missing, there is no suitable replacement (more unobtainium!). Your best bet is to watch eBay, but be sure to get the one pictured. It was only used on the Model Eight (*fig 14*) and the Model Eleven “suitcase stereo”.

Cut a piece of the speaker cloth about 5¾” x 10¾”. Run a bead of *Aleene’s Tacky Glue* (available in craft or fabric stores) around the back edge of the Masonite and smooth it out with your finger. Now place the board face down on the cloth and fold over each of the 4 corners, keeping the cloth straight and square, and pulling it snugly (you don’t have to get it *too* tight). Next, glue down one entire edge at a time. The *Aleene’s* is water-soluble and dries quickly. You can use your fingers to work the cloth into the glue, and you may want to use small clamps or clothespins to hold it in place while it dries. This site shows the general procedure, although it shows the stretchy synthetic cloth:

Be very careful not to get glue on the face of the speaker grille cloth. After the glue is totally dry (overnight) use a spray bottle to spritz water on the face of your grille. Blot with a towel

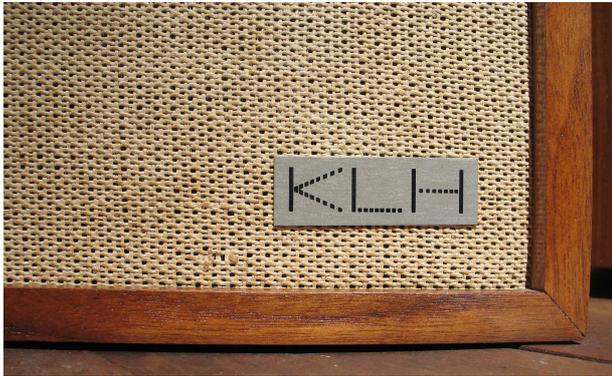
fig 14—Original grille cloth and logo

Oddly, speaker grilles on the Model Eight are often water-stained. And like many parts of the Eight, the speaker grille fabric (shown in *fig 14*) is 100% “unobtainium”. It is very stiff and was cut just about ¼” bigger than the opening so it could be slipped into a groove around the perimeter. If you try to wash it, it will shrink and/or unravel. After much experimenting my favorite replacement is this: Cut a piece of 1/8” Masonite 9 13/16” x 4 13/16”. Use a hole saw to make two 3¼” cutouts (for a 2-driver speaker) or one 3¾” cutout (for a 1-driver speaker). Sand the edges of the cutout, then paint the board black. This board will be covered with linen. Irish Linen or a similar fabric was used on many early New England speakers, and although it is not an exact match for the original KLH cloth, it has an appropriate “vintage” look. The linen can be purchased at reasonable cost at Michael’s craft stores. Look for *CharlesCraft Irish Linen* cross stitch fabric 28 count in “Tea.”

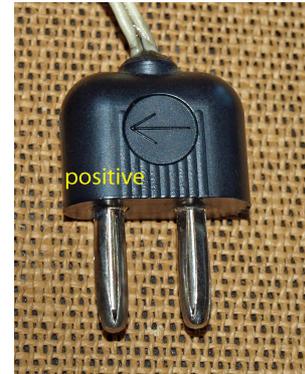
fig 15—speaker plug

2. Later Eights used a single 4” driver and this driver is VERY common. It was used in the Model 21 radio as well as the 5, 11, 12, 14, 15, 19 and several other KLH speakers. They are often found on eBay. Just remove the double 3” speaker baffle and make a new baffle out of 1/8” Masonite with a 4” hole in the center. Note: If you have the original plug, the positive terminal on the speaker is connected to the plug at the tip of the arrow (*fig 15*). Polarity is only an issue when connecting the speaker to the rare KLH Model Thirteen Stereo Adaptor or if using it with the even rarer Model Eight Extension Speaker with its unique “piggyback” adaptor (*shown in fig 3*).

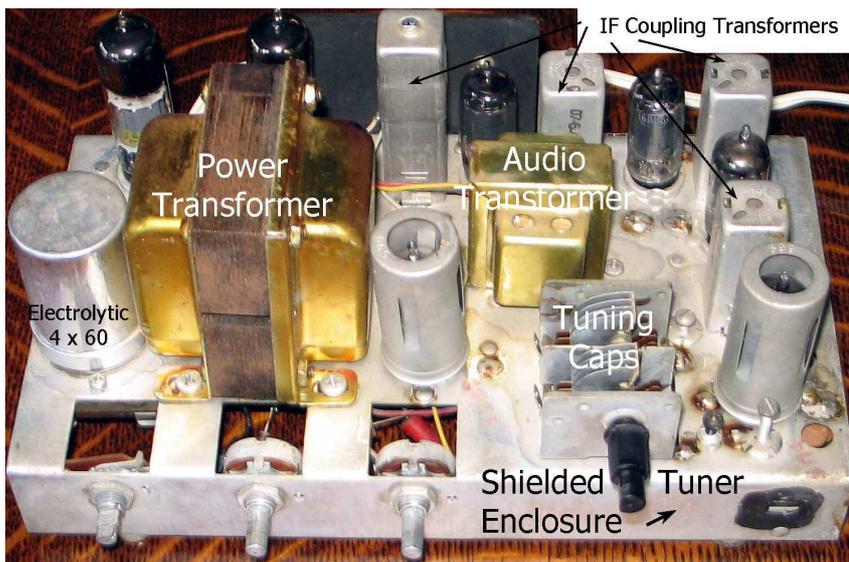
fig 16—chassis

The KLH chassis is pictured here, with the main components labeled (*fig 16*). The seven vacuum tubes are readily available but usually do not need to be replaced. Things like Power Transformers and Tuning Capacitors are unobtainium—if you need one your best bet is to find a “parts” Eight to cannibalize.

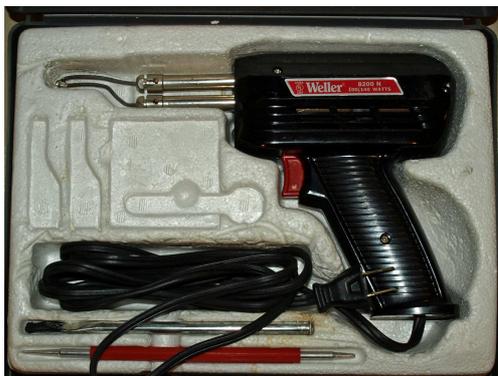
fig 17—soldering gun

First is the 4-part “can” power supply filter cap. The can is aluminum and one of the ground lugs will be soldered to the plated steel chassis. **USE THE RIGHT TOOL FOR THE JOB.** You will need a soldering gun, capable of producing enough heat to melt the solder (*fig 17*). Don’t use your pencil soldering iron (*fig 18*)—it won’t get hot enough and you’ll just burn the tip. When you replace the cap again use the gun to be sure the solder flows and adheres to the chassis forming a good ground (and use flux). Otherwise you may get hum.

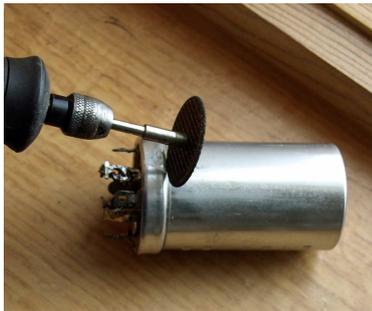
fig 19—cutting can

1. Unsolder the connection to the old can. One tab will be soldered. All four tabs will be twisted for a tight fit. Remove the can, being careful not to break any of the tabs.
2. Using a cutting wheel in a Dremel tool, cut along the bottom seam (*fig 19*).
3. Remove the top of the can and remove/discard all of the stuffing (*fig 20*).

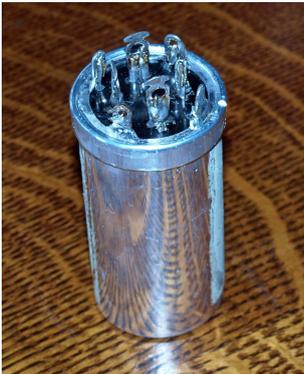
fig 21—completed stuffed can

4. Clean the parts in water and baking soda to neutralize the acid.
5. Drill 1/16" holes in the lugs and through the phenolic bottom plate for the cap leads.
6. Insert the leads of the new caps through the holes. Positive leads go to the 4 lugs, negative go to the outer grounded mounting tabs.
7. Solder the leads.
8. Epoxy the can top back on (*fig 21*).
9. Reinstall the rebuilt cap (*fig 22*). Although it is not critical, try to keep the orientation right (the lug marked with a triangle goes toward the front of the chassis and has the two 220Ω resistors soldered to it).

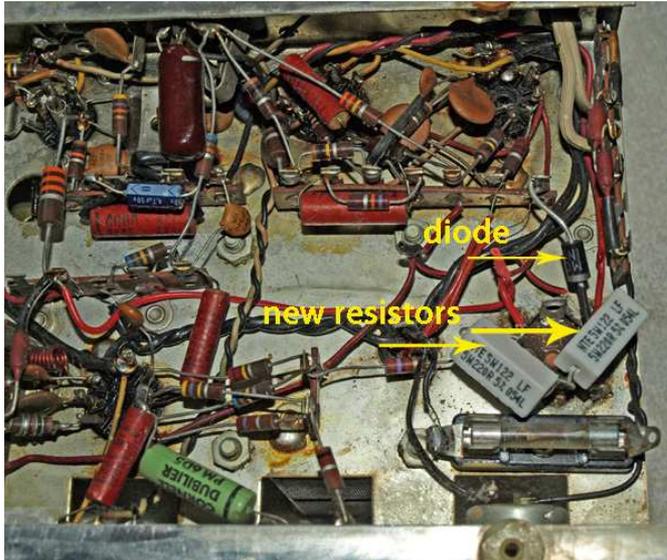
fig 23—new 3-A diode and 5-W resistors

Reconnect all of the wires and components. Because of the higher voltage rating of the new cap, I replace the two 2-W, 220Ω resistors with 5-W resistors and replace the 200-mA diode with a 1N5408 3-A 1000-V rectifier diode because the old diode might not be able to take the new capacitor set's faster charging speed (*fig 23*). The 5-W resistors are tight, but they will fit. You could probably use new 2-W flame-proof metal film resistors but the 5-W sand cast ones are cheap and safe.

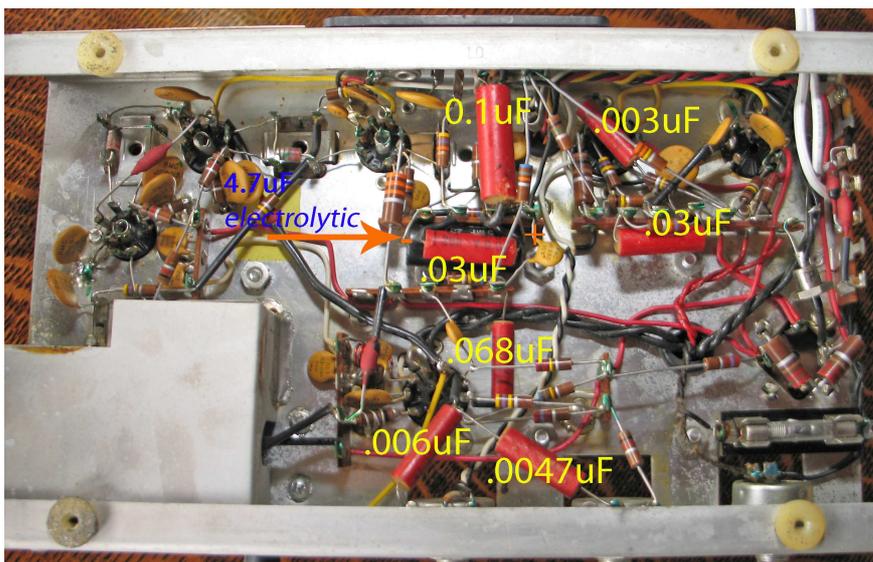
fig 24—capacitor values

The Model Eight has five electrolytic capacitors. It may have up to seven paper caps. In the photos (*figs 23 & 24*) the red tubes that look like firecrackers are paper caps. Some Eights used film caps in some of those spots, so you *may* not need to replace all seven. For example, the green Cornell-Dubilier cap in *figure 23* has a part number on it that showed it to be a plastic film cap. On the other hand, many Eights have brown Dart or Good-All caps that look like plastic film but they may be plastic-coated paper. They have a band around one end, which suggests they are paper. The safest option: **Replace them all.**

The values of the paper caps are marked on the photo (fig 24) but sometimes the original caps are different. In one radio for example, the $.068\mu\text{F}$ cap was $.008\mu\text{F}$ and the $.006\mu\text{F}$ cap was $.03\mu\text{F}$. In those cases I replace with the same values as printed on the originals. Be aware that $\pm 10\%$ is considered to be within spec (it's OK to replace a $.03$ with a $.033$).

The only other electrolytic (besides the big 4-section can) is a 5- μ F in the middle of the chassis (the black cap under the 0.03- μ F red paper cap in *fig 24*). You can replace this with a 4.7- μ F 50-V electrolytic (*the light blue cap in fig 23*). BE SURE TO OBSERVE CORRECT POLARITY! Better yet--you can use a 4.7- μ F 100-V film cap *if* you get one that is physically small enough. The ERO MKT1813 polyester film cap is just 11mm x 30mm and fits nicely. The TECATE 4.7- μ F metalized polyester film caps are a snug fit at 13mm x 30.5mm. Both are available from eBay seller *AudioGrade*.

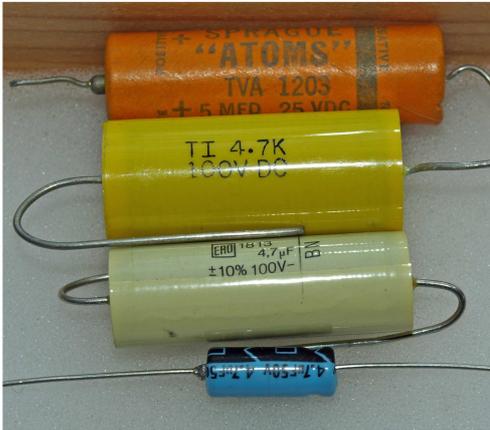
fig 25—Original Sprague electrolytic, Tecate film, ERO film, and new electrolytic

As shown in *figure 25*, the Tecate has a slightly larger diameter than the ERO. The new blue electrolytic is tiny by comparison. An original Sprague 5- μ F cap pulled from a Model Eight is shown for comparison.

Electrolytics leak as they age, resulting in capacitance changes. Spragues were some of the better electrolytics, but after 50 years this one is shot! It tested as 7.5- μ F.

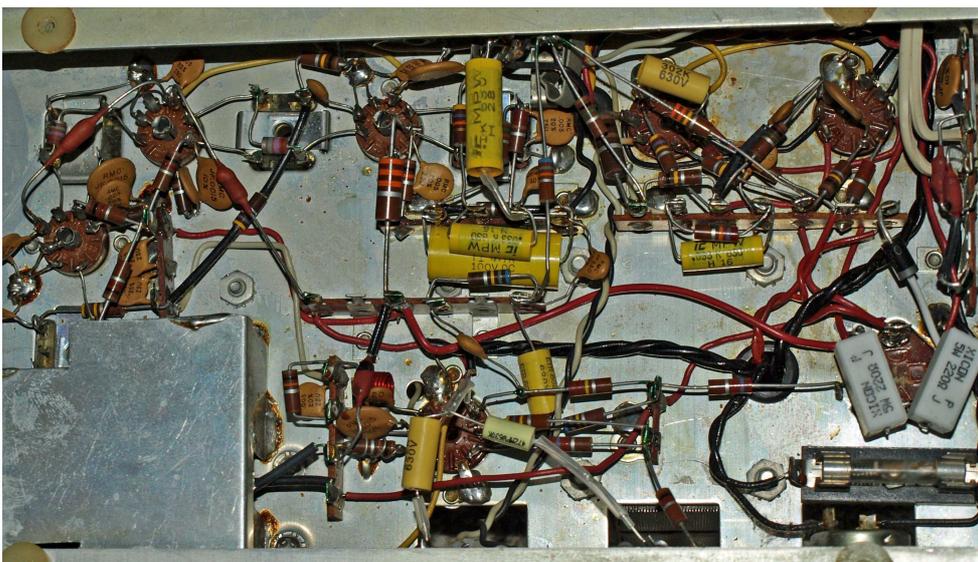
fig 26—completed chassis

Here is a completed chassis with all new (yellow) caps, new 5 watt resistors and diode (*fig 26*)

The neon pilot lamp is an NE2, still available at good electronics stores. It is under the metal shield (lower left-hand corner in *fig 26*). The shield is soldered on and can be removed by desoldering. Be sure to resolder when you are finished. As with the large can capacitor, soldering to the steel chassis is a pain, so be sure to use a solder *gun* and plenty of flux.. The bulb is held in place by a metal clip that is riveted on. I drill out the rivet and replace it with a small machine screw/lock washer/nut. The leads of the neon bulb are soldered to a 68K resistor and to the chassis ground. Instead of soldering to the chassis, I just wrap the lead around the newly-installed machine screw (*fig 29*).

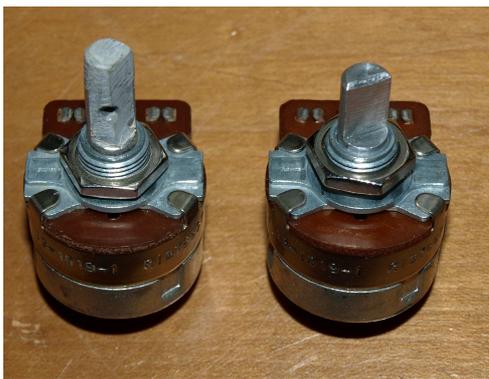
fig 27—CTS on/off switch with extended shaft (left)

The volume and tone pots can be cleaned with a spray control cleaner. The on/off switches are sometimes broken, and oddly enough it is very difficult to find a simple on/off rotary switch. It should have a solid ¼” shaft and about a 30 degree on/off range, but these are nearly impossible to find. Some restorers have resorted to using just the on/off section of an on/off/volume switch, but even these are generally salvaged used parts (and may have a splined shaft). I found some OK replacements at Apexjr.com (CTS SPST Rotary on-off power switch). But the shaft is too short and the “D” profile is not right for the KLH knobs. I ended up slipping a plastic straw over the shaft, filling it with JB Weld and then cutting and filing it to shape (*fig 27*). Very labor-intensive for a 79 cent switch, but it works!

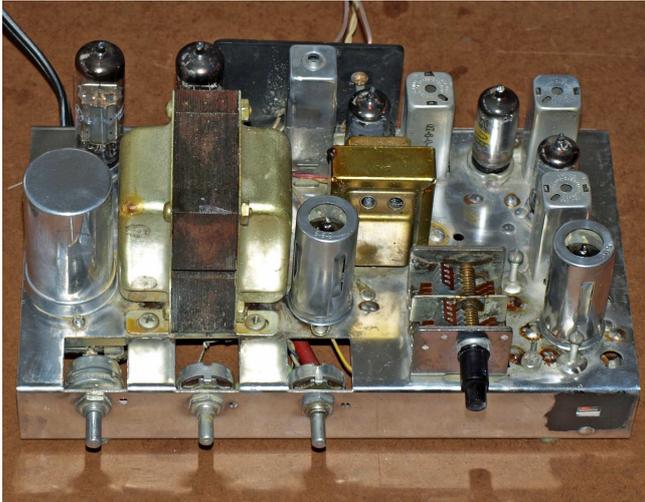
fig 30—polished chassis

Speaking of chassis: If you are compulsive (like me), you can polish the chassis and shields with *MAAS Metal Creme*. This is a tedious task but the result looks nice! (*fig 30*).

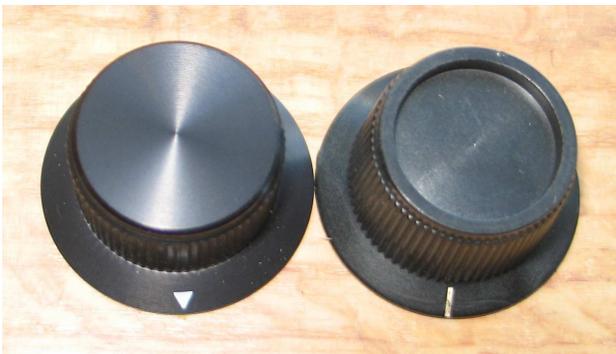
fig 31—Kilo aluminum knob left, original plastic knob right

If the small knobs are missing, or if a control pot has been replaced with one that has a splined shaft that will not accept the original knob, some acceptable replacements are available: The *Kilo International*, part number DDS-90-4-5 in matte black is a high quality solid aluminum knob with 2 set screws that is very close in appearance to the original plastic knob (*fig 31*). They are available from a number of online sellers and local electronics parts shops.

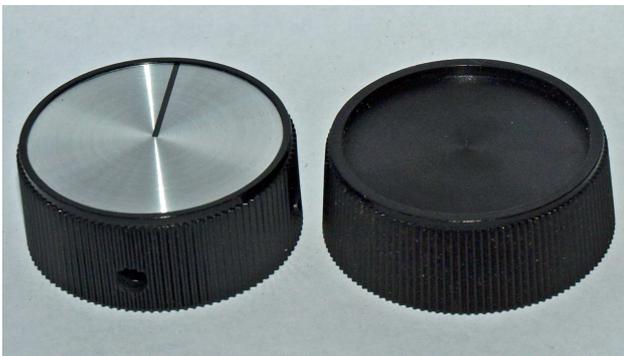
fig 32—new & old tuning knob

There is no perfect replacement for the center tuning knob. I found a 1.9" diameter knob that is close (*fig 32*), but it had an aluminum insert on the face and a 1/4" mounting hole. Remove the aluminum disc (place it in the freezer overnight and the disk should pop off) and sand the center to look like the original (attach it to a 1/4" rod, chuck it into an electric drill, and sand the face while it spins). Use a brass adaptor bushing to make it fit on the 1/8" shaft (*fig 33*). These are discontinued but a good replacement is a 1/4" OD aluminum spacer from "Aluminum Spacers"

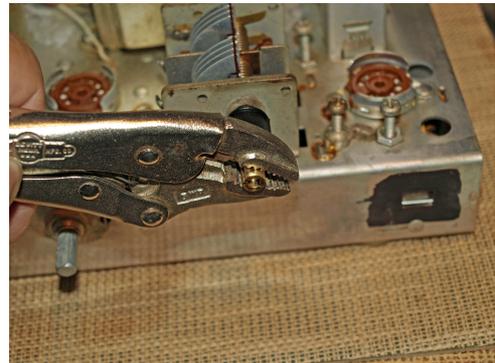
fig 33—installing shaft bushing

Cut a slit along the length of the spacer with a cutting wheel in a Dremel tool so the spacer can be crimped on to the shaft.

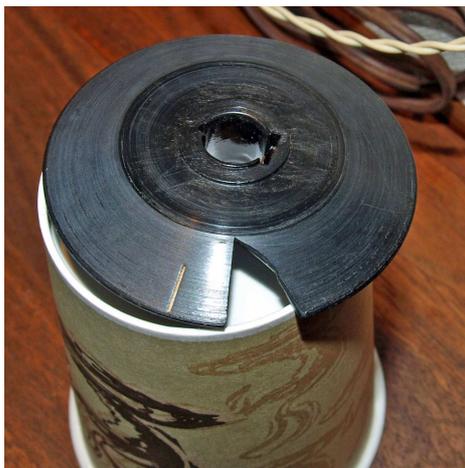
fig 34—broken tuning dial

The outer tuning dial may present a problem. If it is cracked or chipped it can be repaired with *Plas-T-Pair*. But if it is missing, there is no replacement. I had some hand made by a woodturner who happens to be a close friend, but if you had to pay for them. . . .

Here's how to repair a chip: Put tape over the void on the front of the knob and on the edge to make your "dam." Mix some *Plas-T-Pair* and *Evercoat* as previously described and slowly (to avoid air bubbles) pour it in from the back (*figs 34 & 35*). After 24 hours, remove the tape. Wait a week or more before sanding any irregularities. A final buff with steel wool should make the patch all but invisible. In *fig 36*, the patch is at the top of the dial. I had to enhance the photo in PhotoShop to make it visible at all!

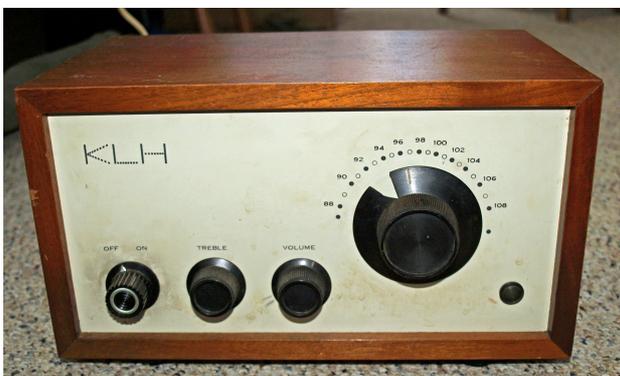
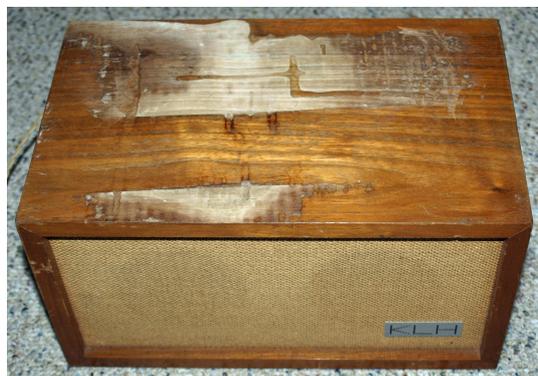
After following these guidelines, you will have transformed your Model Eight from this:

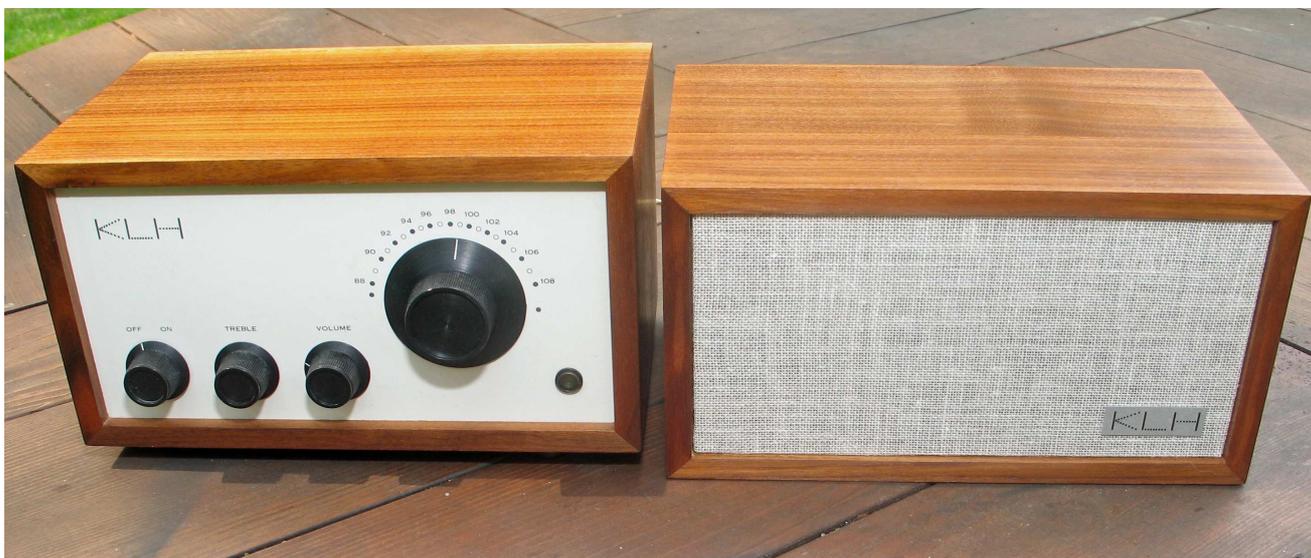
to this:

Now that the radio has been repaired and refurbished, place it in a prominent spot, turn it on (and wait while it warms up!) and enjoy the rich, full sound.
