Restoring the KLH Model Eight Table Radio

This guide is based on my experience restoring dozens of these and is intended for the advanced hobbyist. You don't have to be a technician or have the ability to read a schematic. If you are comfortable building a *dynakit* you should be able to follow these instructions.

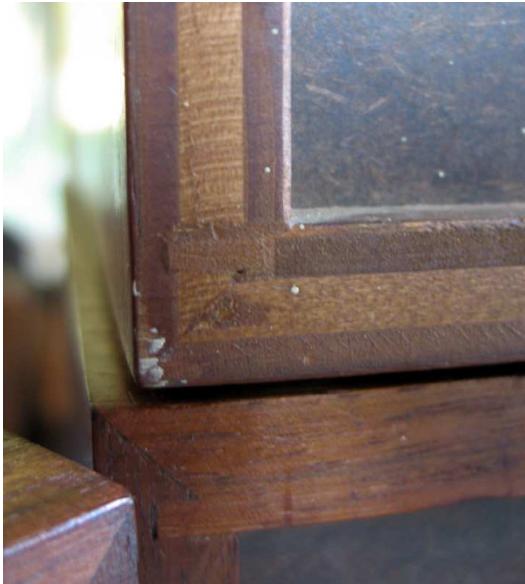
fig 1 --Veneer (top) and solid (bottom) cabinets

- What is the condition of the cabinets? Are there any scratches, gouges, corner dings, water stains, etc? Early cabinets were solid walnut while later ones were high quality walnut veneered plywood. A look at the back edges on both the receiver and speaker will reveal what you have(*fig. 1*).

At this point you'll have to decide whether the cabinets need to be refinished. The solid ones can be sanded aggressively with an orbital sander. I would NOT sand veneer unless absolutely necessary—and then only by hand. For veneer cabinets I recommend *Howard's Restor-a-Finish*, available at hardware stores, online and Home Depot.

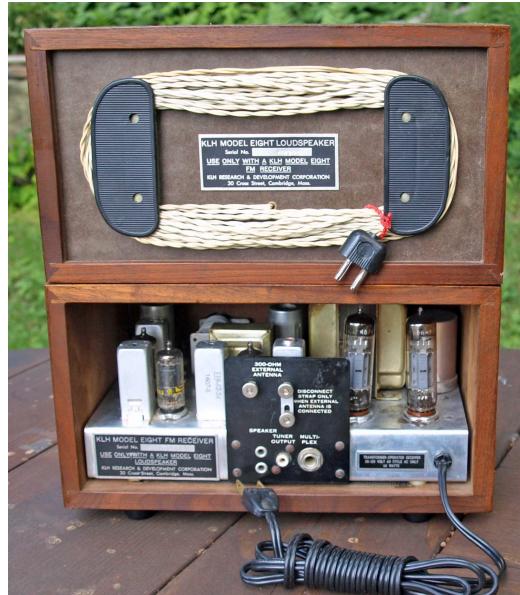
fig 2 – Radio back

- Are the plastic cleats on the back of the speaker intact? These are often broken.
- Other things to look for are the metal labels (2) on the back of the receiver and (1) on the back of the speaker. Serial numbers rarely match (I have an original factory carton, with serial numbers of the receiver and speaker on the outside. They don't match). Check the AC power cord for cracks and stiffness. There should be 3 knurled nuts and a small strap on the back of the receiver for the antenna connections (*fig 2*).

The knurled nuts for the antenna, if missing, may be replaced with solid brass knurled nuts available in hardware stores. If the antenna strap is missing, a piece of bare wire or even a paper clip can be used as a jumper.

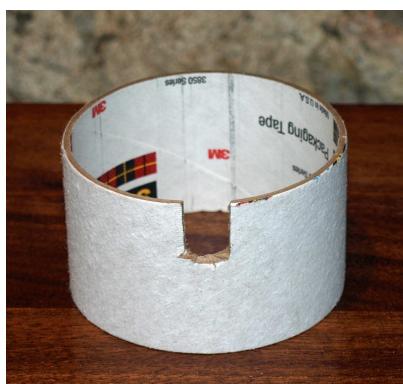
fig 3—knob-removal “tool”

The receiver chassis can be removed by *gently* removing the knobs, then unscrewing the four Phillips-head screws holding the feet to the bottom of the cabinet. To remove the knobs use your fingers and fingernails only. Rock and pull straight out. Do not use a screwdriver or any other tool to pry the knobs—you run the risk of breaking the brittle plastic or damaging the painted faceplate. As a last resort, you can make a knob-puller from the cardboard center of a roll of packing tape (*fig 3*). Cut a notch in the cardboard and slip it under the knob, so the shaft slips into the notch (thanks to Tim Schwartz of Bristol Electronics for this tip).

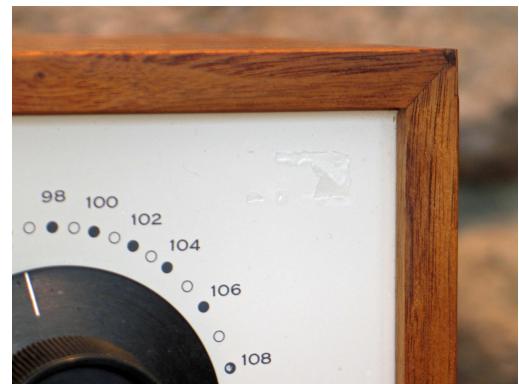
fig 4 – repaired paint chip

Once the knobs and feet have been removed, slide out the chassis and set it aside. The painted faceplate can be cleaned with soap and water, *Fantastik*, 409 or similar cleaner. Do NOT use any kind of abrasive! If the faceplate is scratched or the lettering is rubbed off there is little you can do. I have touched up small scratches and chips by spraying almond spray paint into a cup, then brushing it on with a very fine paintbrush (*fig 4*).

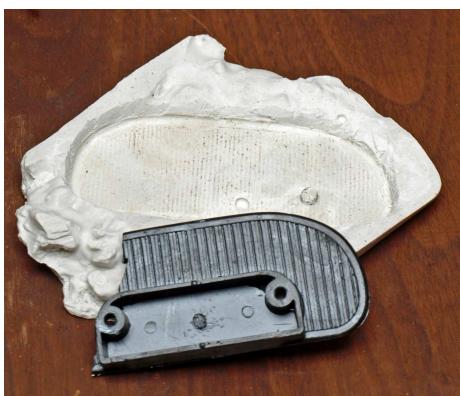
fig 5 – broken cleat & plaster mold

If a cleat is broken, you can remove it by drilling out the metal rivets. This is best accomplished from inside the speaker cabinet. Assuming the grille cloth has been removed, unscrew the #4 flat head Phillips screws holding the speaker baffle in place, and pull the baffle off. It is caulked with some putty that is probably dried out and may require some gentle prying (be careful of the walnut frame), but it will come loose. Inside is some pink fiberglass insulation. Remove it (gloves and a mask are a good idea) and save it in a plastic bag. Now drill out the rivets from the inside. Later the cleats can be reattached with #4 machine screws, lock washers (or *Loctite*) and nuts.

To restore a cleat, I made a cast of an intact cleat using Plaster of Paris. A better choice would be a product for making molds, sold in art stores. After you have your mold, set the broken cleat in it, then pour in a mixture of *Plas-T-Pair*. This product may also be used for patching broken knobs.

Plas-T-Pair is available online at <http://www.radiodaze.com/spec-plas-t-pair.htm> It consists of powdered plastic and a liquid solvent. Follow the directions and work in a ventilated area. The product will dry cream-color, so to repair black plastic add a few drops of *Evercoat* black coloring agent to the mix. It is sold in auto body or marine supply stores. Pour the black *Plas-T-Pair* mix into the mold, let it cure 24 hours and remove your restored cleat (figs 5 & 6). A similar method can be used to make repairs to the plastic knobs (more on that later).

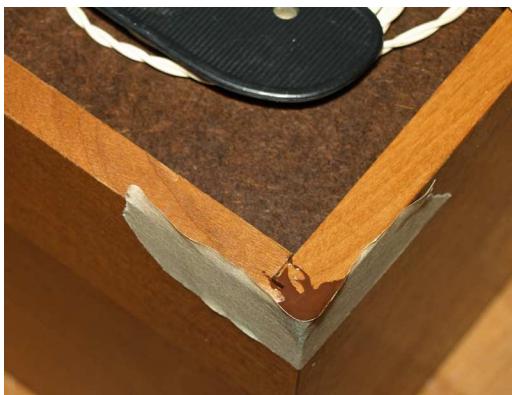
fig 7—corner bash, tape dam and epoxy filler

Mixol is sold in art supply and woodworking stores. It comes in a small (20 ml) bottle, costs about \$5 and you need only a drop added to your epoxy. "Tobacco" #22 is a good match for the dark walnut wood. On corners build a dam out of masking tape and pour the epoxy mixture in (*fig 7*). Open seams can be re-glued by forcing the tinted glue into the joint with a razor blade or X-acto knife, then clamping (*fig 8*). After 24 hours it can be filed and sanded down. It is MUCH more durable than "plastic wood".

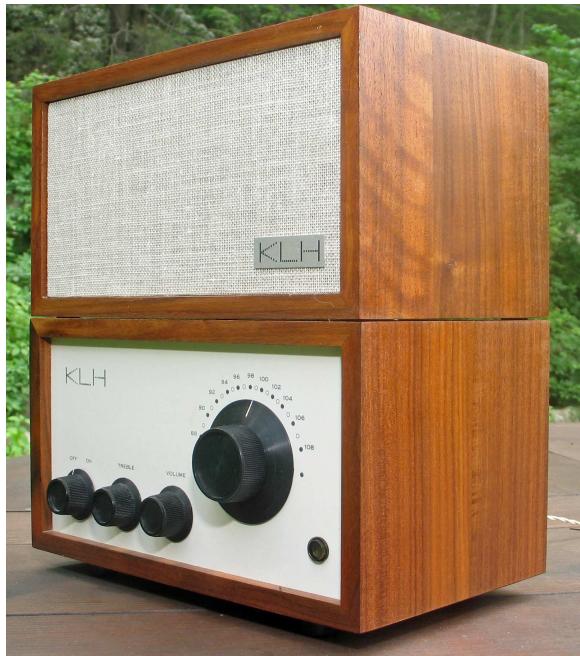
fig 9—Irish Linen grille cloth

Be very careful not to get glue on the face of the speaker grille cloth. After the glue is totally dry (overnight) use a spray bottle to spritz water on the face of your grille. Blot with a towel then dry with a hair dryer. The fabric will shrink to be as tight as a drum (*fig 9*). You can spray it with *ScotchGuard* if you want, then glue the KLH logo on with *Aleene’s*. If the logo was missing, there is no suitable replacement (more unobtainium!). Your best bet is to watch eBay, but be sure to get the one pictured. It was only used on the Model Eight (*fig 10*) and the Model Eleven “suitcase stereo”.

Cut a piece of the speaker cloth about $5\frac{3}{4}$ ” x $10\frac{3}{4}$ ”. Run a bead of *Aleene’s Tacky Glue* (available in craft or fabric stores) around the back edge of the Masonite and smooth it out with your finger. Now place the cloth on the front and fold over each of the 4 corners, keeping the cloth straight and square, and pulling it snugly (you don’t have to get it *too* tight). Next, glue down one entire edge at a time. The *Aleene’s* is water-soluble and dries quickly. You can use your fingers to work the cloth into the glue, and you may want to use small clamps or clothespins to hold it in place while it dries. This site shows the general procedure, although it shows the stretchy synthetic cloth:

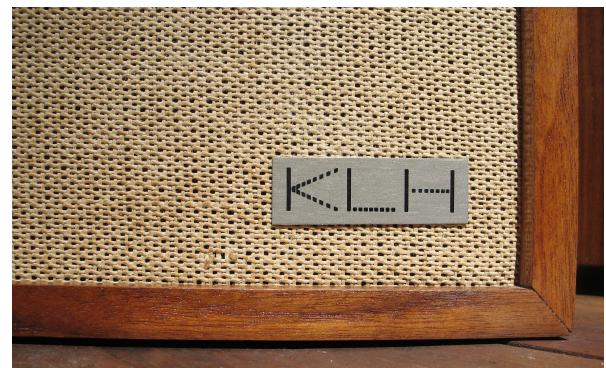
fig 10—Original grille cloth and logo

Oddly, speaker grilles on the Model Eight are often water-stained. And like many parts of the Eight, the speaker grille fabric (shown in *fig 10*) is 100% “unobtainium”. It is very stiff and was cut just about $\frac{1}{4}$ ” bigger than the opening so it could be slipped into a groove around the perimeter. If you try to wash it, it will shrink and/or unravel. After much experimenting my favorite replacement is this: Cut a piece of $\frac{1}{8}$ ” Masonite $9\frac{13}{16}$ ” x $4\frac{13}{16}$ ”. Use a hole saw to make two $3\frac{1}{4}$ ” cutouts (for a 2-driver speaker) or one 4” cutout (for a 1-driver speaker). Sand the edges of the cutout, then paint the board black. This board will be covered with Irish Linen. Linen or a similar fabric was used on many early New England speakers, and although it is not a match for the original KLH cloth, it has an appropriate “vintage” look. The linen can be purchased at reasonable cost at Michael’s craft stores. Look for *CharlesCraft Irish Linen* cross stitch fabric 28 count in “Tea.”

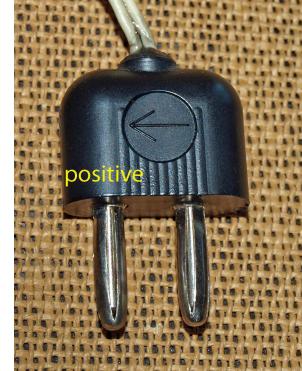
fig 11—speaker plug (against original speaker cloth)

- How does the speaker cloth look? Water stains seem to be common. Is the KLH logo badge on the cloth?
- Is the 30' white twisted pair speaker wire intact? The proprietary double banana plug is often missing due to a design flaw, and typically will have been replaced with two standard banana plugs.

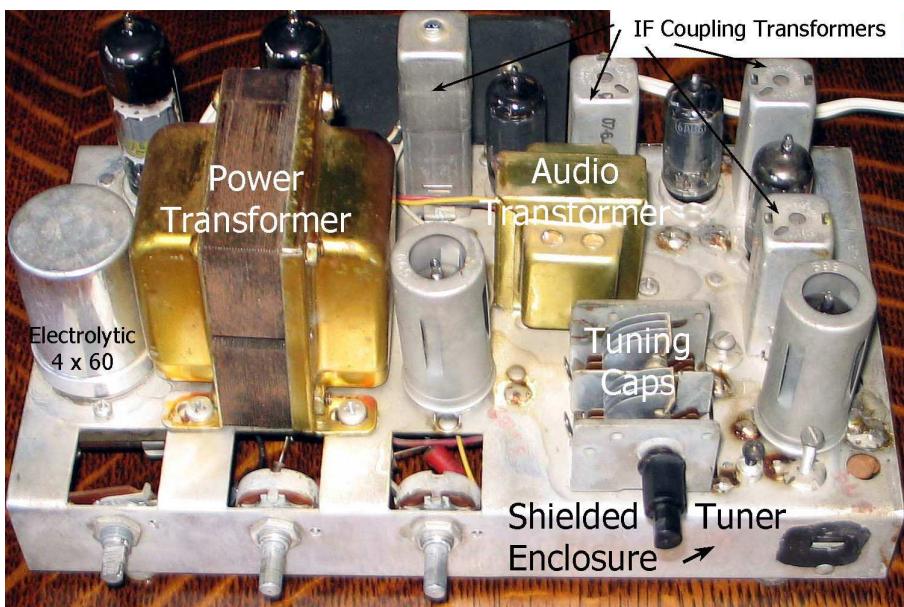
fig 12—chassis

The KLH chassis is pictured here, with the main components labeled (fig 12). The vacuum tubes are readily available but usually do NOT need to be replaced. Things like Power Transformers and Tuning Capacitors are unobtainium—if you need one your best bet is to find a “parts” Eight to cannibalize.

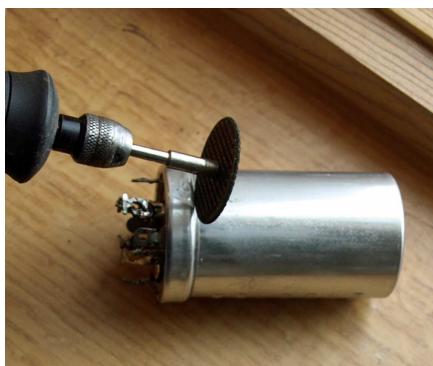
fig 13—cutting can

2. Using a cutting wheel in a Dremel tool, cut along the bottom seam (*fig 13*).
3. Remove the top of the can and remove/discard all of the stuffing (*fig 14*).

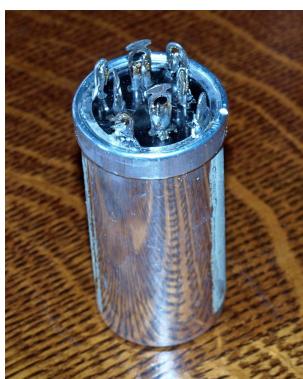
Fig 15—completed stuffed can

6. Insert the leads through the holes. Positive leads go to the 4 lugs, negative go to the outer grounded mounting tabs.
7. Solder the leads.
8. Epoxy the can top back on (*fig 15*).

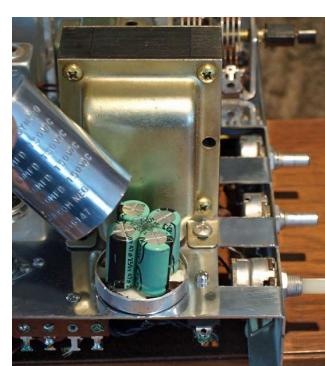
fig 16—installed on chassis

9. Reinstall the rebuilt 4-section cap (*fig 16*). Although it is not critical, try to keep the orientation right (the lug marked with a triangle goes toward the front of the chassis and has the two 220 Ω resistors soldered to it).

The only other electrolytic is a $5\text{-}\mu\text{F}$ in the middle of the chassis (*the black cap under the $0.03\text{-}\mu\text{F}$ red paper cap in fig 18*). I replace this with a $4.7\text{-}\mu\text{F}$ 50-V electrolytic (*the light blue cap in fig 16*). BE SURE TO OBSERVE CORRECT POLARITY!

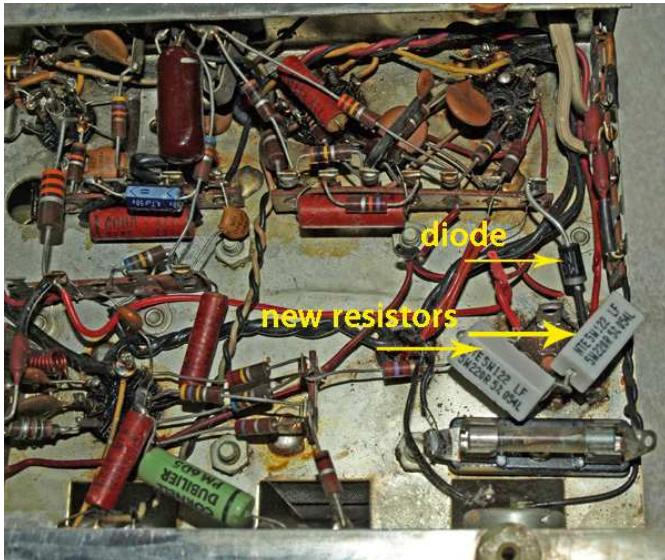
fig 17—new components

Reconnect all of the wires and components. Because of the higher voltage rating of the new cap, I replace the two 2-W, 220Ω resistors with 5-W resistors and replace the 200-mA diode with a 1N5408 3-A 1000-V rectifier diode (because the old diode might not be able to take the new capacitor set's faster charging speed) (*fig 17*).

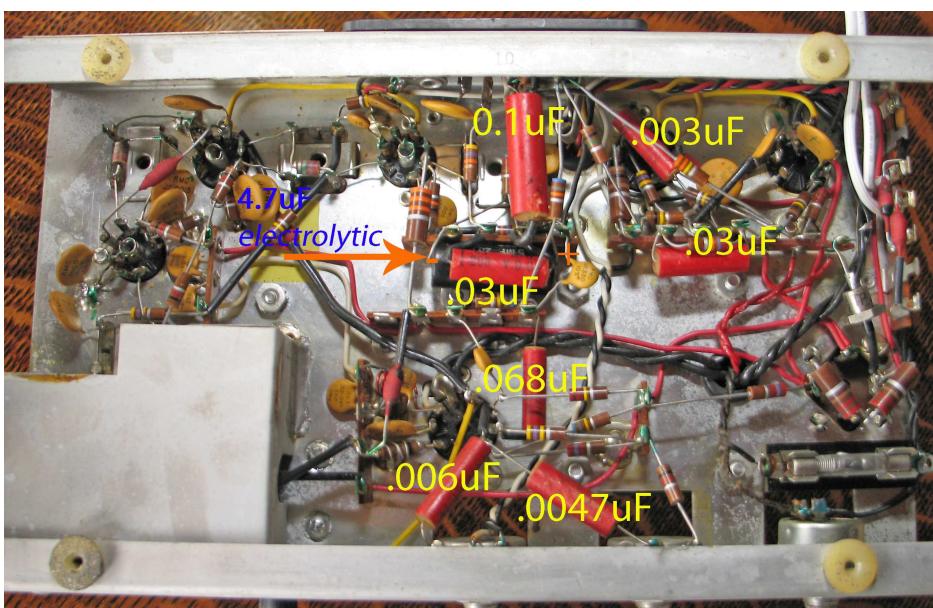
fig 18—capacitor values

The Model Eight has five electrolytic capacitors. It “may” have up to seven paper caps. In the photos (figs 17 & 18) the red tubes that look like firecrackers are paper caps. Some Eights used film caps in some of those spots, so you may not need to replace all seven. For example, the green Cornell-Dubilier cap in figure 16 has a part number on it that showed it to be a plastic film cap. On the other hand, many Eights have brown Dart or Good-All caps that may be plastic film but they also may be plastic-coated paper. They have a band around one end, which suggests they may be paper. The safest option: When in doubt, replace.

The values of the paper caps are marked on the photo (*fig 18*) but sometimes the original caps are different. In one radio for example, the $.068\mu\text{F}$ cap was $.008\mu\text{F}$ and the $.006\mu\text{F}$ cap was

.03 μ F. In those cases I replace with the same values as printed on the originals. Be aware that +/-10% is considered to be within spec (it's OK to replace a .03 with a .033).

A good source for replacements is www.justradios.com although for one radio it may be more practical to buy the parts locally, IF you can find them. Use good quality film caps of at least 200 volt rating (I use 600 to 630-V whenever possible).

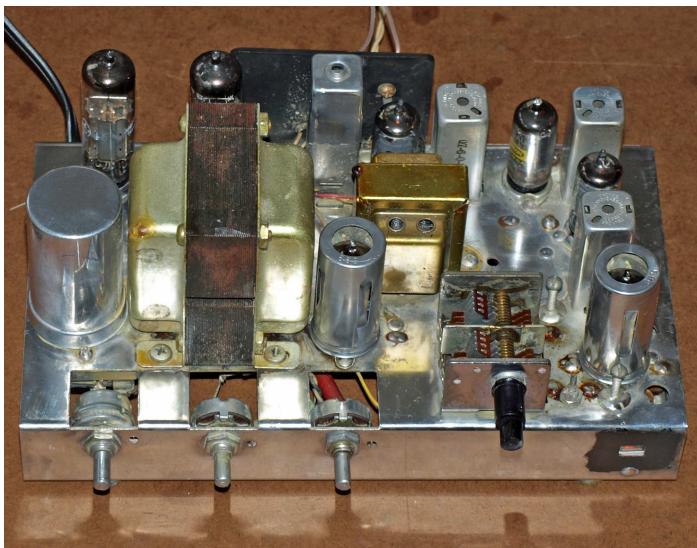
fig 19—polished chassis

If you are compulsive (like me), you can polish the chassis and shields with *MAAS Metal Creme*. This is a tedious task but the result looks nice! (fig 19).

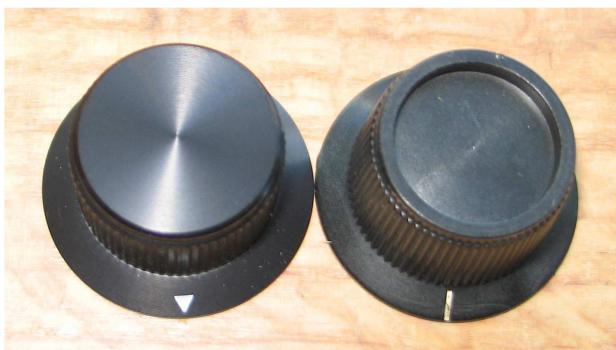
fig 20—Kilo aluminum knob left, original plastic knob right

Now that the electronics are complete, you can put the chassis back in the cabinet and reinstall the knobs. If the small knobs are missing, or if a control pot has been replaced with one that has a splined shaft that will not accept the original knob, some acceptable replacements are available: The *Kilo International*, part number DDS-90-4-5 in matte black is a solid aluminum knob with 2 set screws that is very close in appearance to the original plastic knobs (*fig 20*). They are available from a number of online sellers. My local parts shop stocks them, but they cost about \$10 apiece!

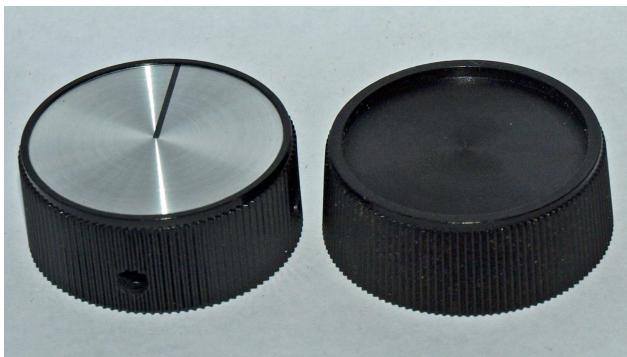
fig 21—new & old tuning knob

There is no perfect replacement for the center tuning knob. I found a 1.9" diameter knob that is close (*fig 21*), but it had an aluminum insert and a 1/4" mounting hole. Remove the aluminum disc (place it in the freezer overnight and the disk will pop off) and sand the center to look like the original. I used an adaptor bushing to make it fit on the 1/8" shaft (*fig 22*).

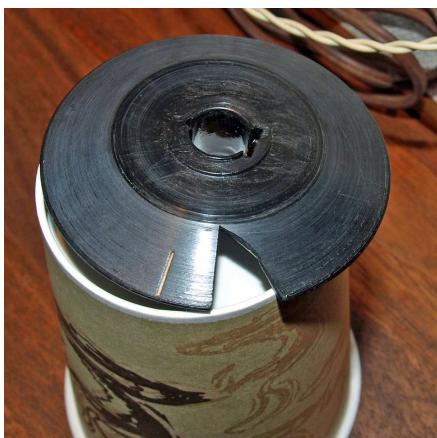
fig 23—broken tuning dial

The outer tuning dial may present a problem. If it is cracked, it can be repaired with *Plas-T-Pair*. But if it is missing, there is no replacement. I had one hand made by a woodturner who happens to be a close friend, but if I had to pay for it. . . .

Here's how to repair a chip: Put tape over the void on the front of the knob and on the edge to make your "dam." Mix some *Plas-T-Pair* and Evercoat as previously described and slowly (to avoid air bubbles) pour it in from the back (*figs 23 & 24*). After 24 hours, remove the tape. Wait a week before sanding any irregularities. A final buff with steel wool should make the patch all but invisible. In *fig 25*, the patch is at the top of the dial. I had to enhance the photo in PhotoShop to make it visible at all!

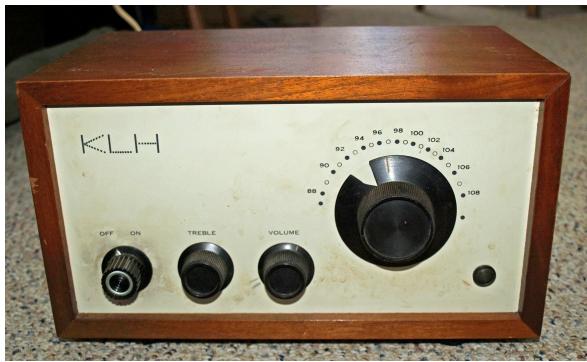
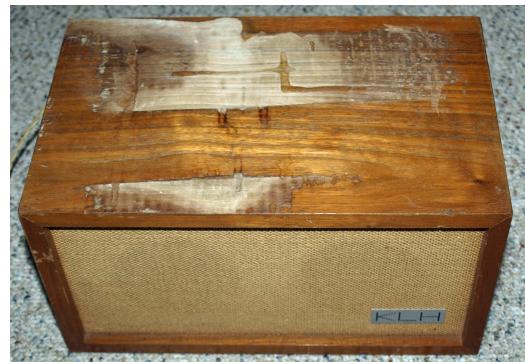
After following these guidelines, you will have transformed your Model Eight from this:

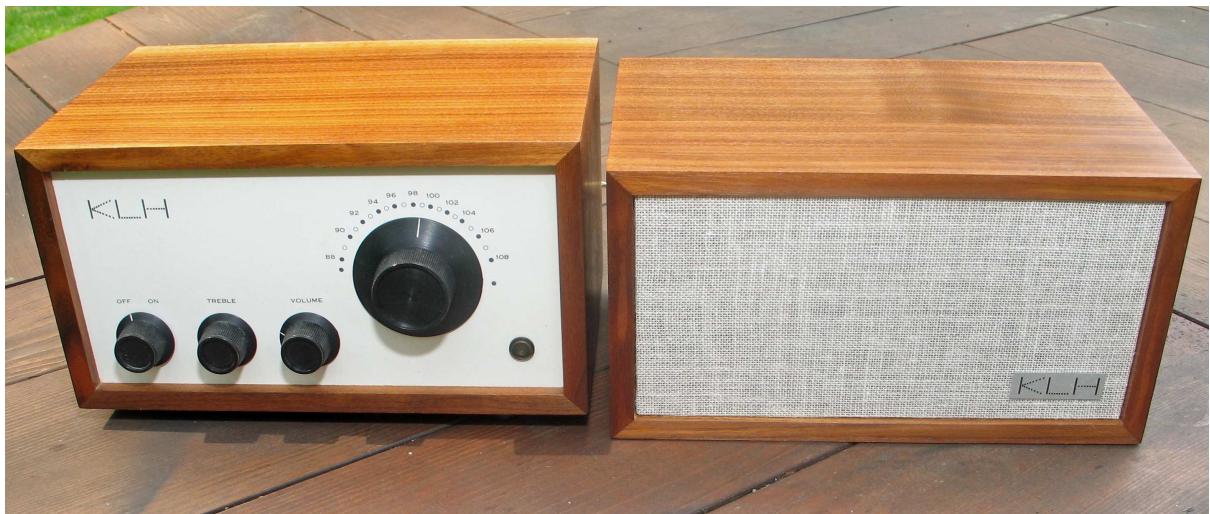
to this:

Now that the radio has been repaired and refurbished, place it in a prominent spot, turn it on (and wait while it warms up!) and enjoy the rich, full sound. One last note: Be sure to allow plenty of air circulation around the receiver, and do NOT place anything (like the speaker for example) on top of the receiver. Many old Eights have split or blistered top panels on the receiver cabinet from excessive heat.
