AR-3 Crossover Schematics

During its production cycle, AR modified the AR-3 crossover schematic several times. This note attempts to catalog those changes based on detailed information available in Tom Tyson's files. At some point a complete description of the AR-3 will be written [TT]; at that time this should become an appendix within that document.

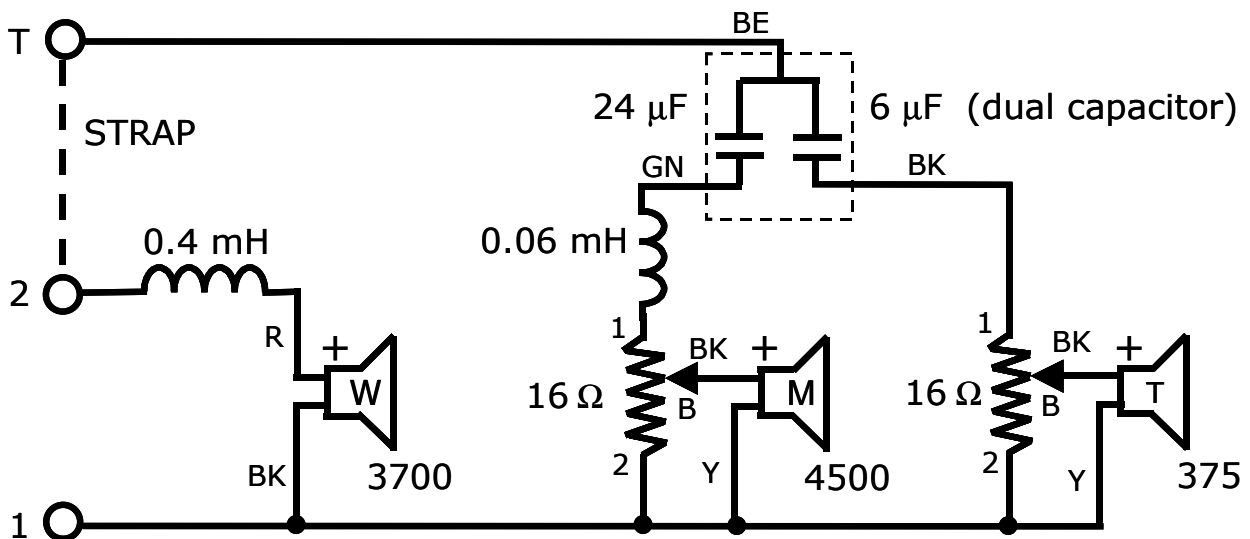
A. Initial production through serial number C1413:

The schematic shown here; dated 13 March 1959 and initialed by EMV, is the original AR-3.

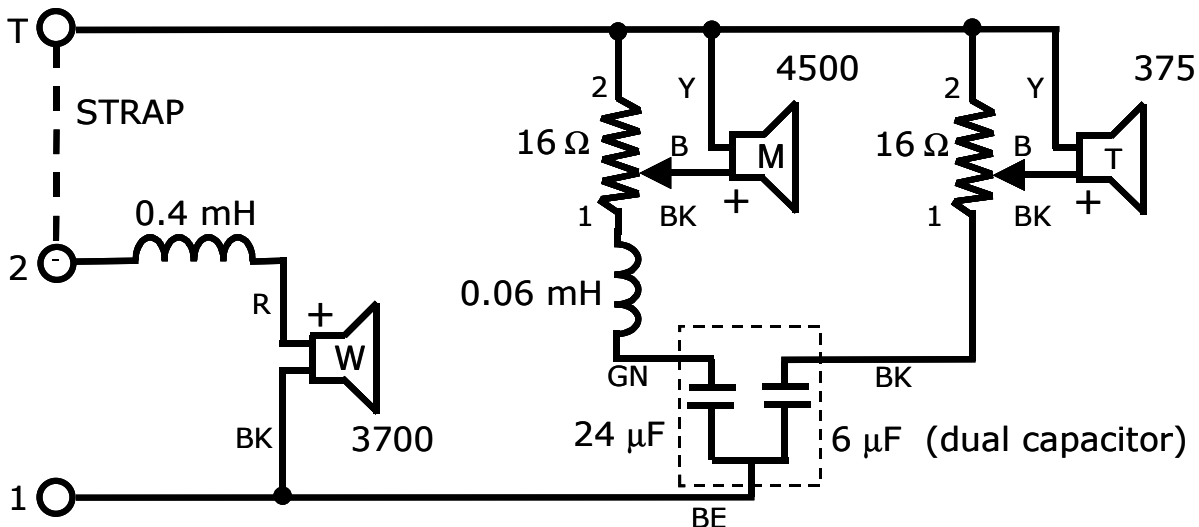
B. Serial numbers C1414 – C19467:

In 1960 the crossover was changed to reverse the phase of the mid-range and tweeter with respect to the woofer [1]. This was the only change made at this point in production.

[1] Phase reversal was initially done manually by reversing the midrange/tweeter wiring with respect to the woofer. At some point, AR either reversed magnet polarization or internal coil wiring to change this phase internally. It is a daunting task to determine whether or not a particular AR-3 is in-phase or out-of-phase. The acoustically measured effect is only *slightly* noticeable and only barely audible—*not* to a great extent. Quite frankly, room-acoustic artifacts can have a much greater influence on the output of the AR-3 than the simple dc phasing reversal. If your AR-3 has never been opened or modified or repaired, it is almost assured that the dc phasing is correct for that speaker, so do not worry about attempting to change it. On the other hand, if a replacement driver of unknown pedigree was installed, then all bets are off. In order to determine exactly the phase relationship, the speaker must be electrically measured with a sine-wave oscillator and oscilloscope or with response measurements at the crossover frequencies, but this is quite difficult to determine accurately without professional test equipment. In the end, it's probably best not to worry about the phasing. If the speaker sounds too bright around the midrange crossover frequency (around 1000 Hz), and it is noticeable, you may reverse the lead-in wires from the midrange driver to the terminal strip (thus reversing the polarity of the midrange driver on the tweeter terminal strip on the front speaker baffle board under the grill). Since nearly all AR-3s used aluminum wire from the tweeters, soldering the aluminum lead-in pigtailed requires AlumiSol aluminum solder to properly bond, so care must be used when unsoldering and re-soldering to insure a proper solder joint. An alternative technique for joining aluminum to copper by a crimp connection is described in the AR restoration document.

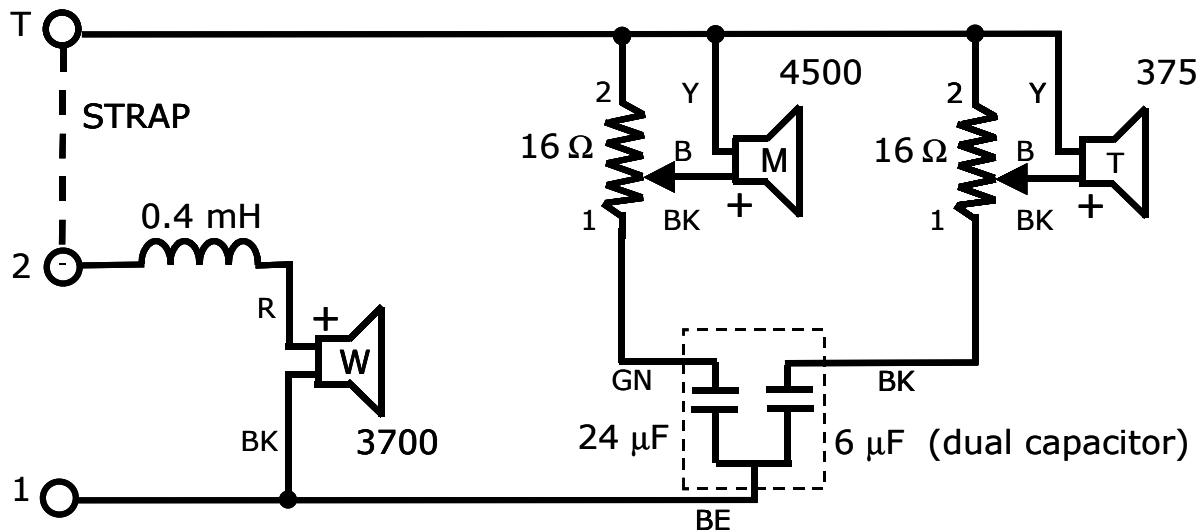
C. Serial numbers C19468 – C70228:

The crossover was modified on 25 Aug. 1965 by removing the 0.06-mH (51-turn) coil in the mid-range crossover.

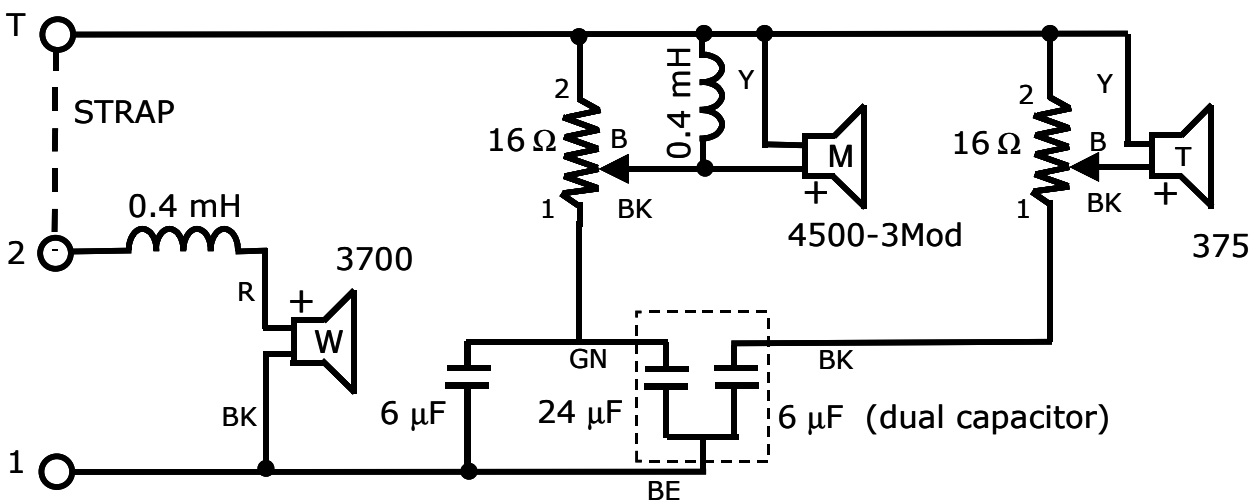
D. Serial numbers C70229 to end of production:

On 13 May 1970, AR ran out of the original phenolic-dome mid-range. This required the use of a version of the AR-3a mid-range identified by part number 4500-3MOD and later identified as part number 200010-AR-3 or 200019-3. (These are Fig's. A.9 and A.10, respectively, in *Restoring the AR-3a.*) This required a crossover change, as the AR-3 and AR-3a did not have the same woofer-mid-range crossover frequency. This crossover change consisted of the addition of a 6- μ F capacitor in parallel with the 24- μ F (to make a total of 30 μ F) and the addition of a 0.4-mH (143-turn) coil across the mid-range driver. These changes are illustrated below.

After the original mid-range supplies were exhausted, the new driver described in Section D was used for both production and service replacement. *So it is possible that an Internet-purchased speaker contains a service replacement mid-range.* Service replacement was not straightforward, as the crossover had to be changed to that shown in Section D. Thus, speakers with serial numbers of C19467 and lower needed to have their 51-turn coil removed before the parts for the new service replacement were added. Speakers with serial numbers greater than C70228 would not have needed the crossover modification, since the new style mid-range was installed when originally assembled.

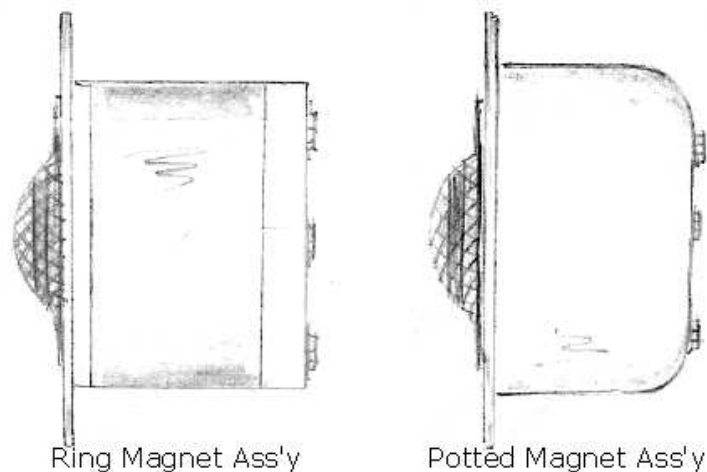
G. Mid-range Magnet Structure:

At some point in the 30,xxx serial number range, AR changed the magnet structure from the modified form of the AR-1W, to a potted type magnet. The two cross-sectional views are shown here. These two styles are equivalent.
